## LDO & LSO GARAGE DOOR OPERATOR OPEN LIMIT SWITCH ADJUSTMENT

### **IMPORTANT BULLETIN - FIELD ACTION REQUIRED**

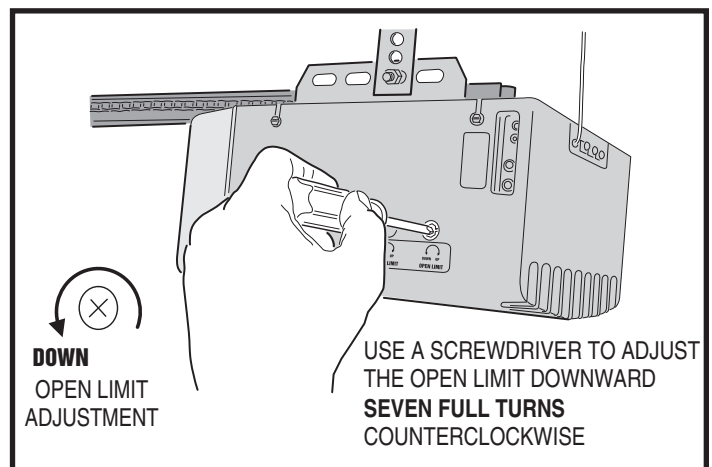
Adjusting the Open Limit on an LDO Operator

**To prevent possible damage to the operator and/or rail components, BEFORE APPLYING POWER TO THE OPERATOR, turn the OPEN LIMIT adjustment screw downward (counterclockwise) seven (7) full turns. This will return the operator to the normal factory setting. After adjusting, FOLLOW ALL PRINTED INSTRUCTIONS supplied with the operator.**
