LRA EN12 ISSUE

LRA Actuator and APeX Controller

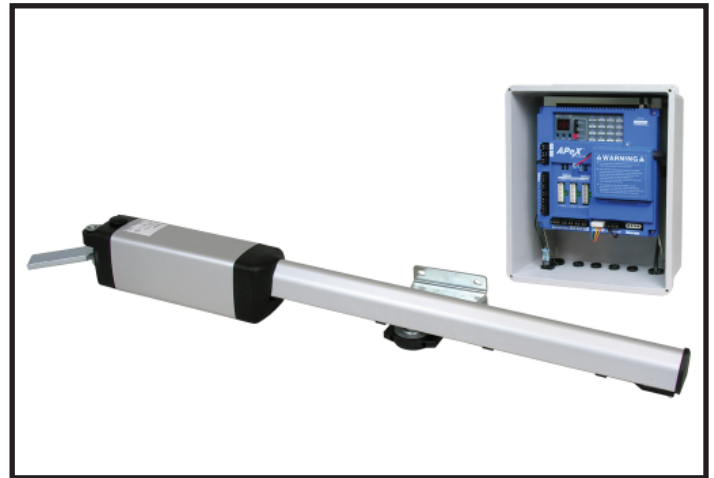
The Model LRA Swing Gate Operator running APeX Controller firmware Version 1.0 or lower can experience difficulty detecting arm presence when used not installed on a gate or on very small or lightweight gates, resulting in an EN12 error code.

Upgrading the Controller to firmware Version 1.1 or higher will eliminate this issue.

A field solution for installations running Version 1.0 or lower firmware is to install a 100 ohm, 10 Watt resistor (i.e. Radio Shack P/N 271-0135) across Terminals #1 and #2 on the controller terminal strip (this is parallel to the motor connections). After installing the resistor, re-program the Controller's force settings.
