## LDO & LSO GARAGE DOOR OPERATOR OPEN LIMIT SWITCH ADJUSTMENT

### **IMPORTANT BULLETIN - FIELD ACTION REQUIRED**

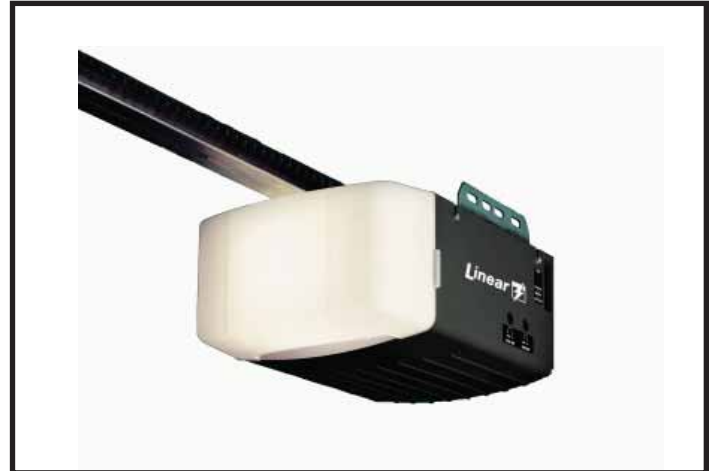
LDO33 and LDO50 Garage Door Operators

This bulletin applies to all Linear Model LDO & LSO garage door operators manufactured from December 3rd, 2007 to April 6th, 2008. Products manufactured between these dates have the preset factory location of the open limit adjustment set abnormally high. This can affect operator setup and testing in 7-foot and 8-foot rail installations.

If the open limit is not readjusted prior to testing the operator, with the trolley disconnected from the traveler (also known as the inner slide), it is possible to overrun the traveler into the drive sprocket during testing. This can cause damage to the traveler and/or the operator.

**To prevent possible damage to the operator and/or rail components, BEFORE APPLYING POWER TO THE OPERATOR, turn the OPEN LIMIT adjustment screw downward (counterclockwise) seven (7) full turns. This will return the operator to the normal factory setting. After adjusting, FOLLOW ALL PRINTED INSTRUCTIONS supplied with the operator.**
